# Manhole Inspection Summary

Manhole # S33E\_\_001MH

Insp Date: **8/4/08 9:16 AM**

**Location** Address: **39 w lexington st**

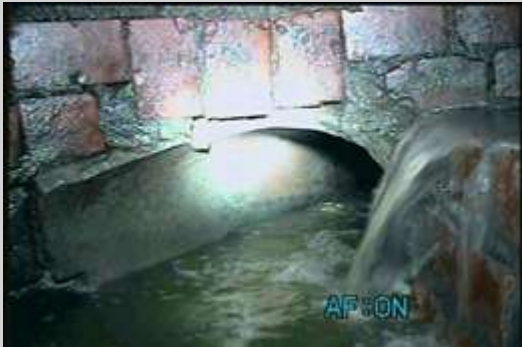
12 O'Clock Outflow

10 in. Circular Gravity Sewer  
Pipe Out @ 12 O'Clock

Pipe Material: **Clay** ☐ Pipe Lined

Invert Depth: **16.26** (ft.) Flow Characteristics: **Fast**

Deposits: ☒ None ☐ Mud ☐ Sludge ☐ Debris ☐ Grease

Infiltration: **None** Pipe Seal Cond: **Unknown**

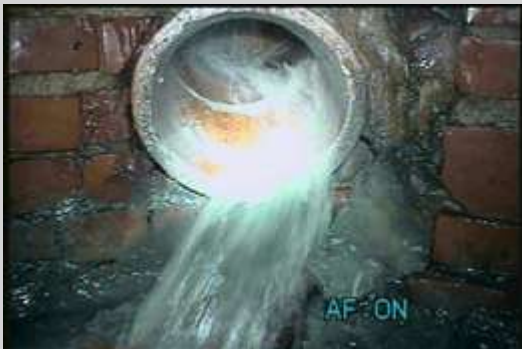
5 O'Clock Inflow

8 in. Circular Gravity Sewer  
Pipe In @ 5 O'Clock

Pipe Material: **Clay** ☐ Pipe Lined

Invert Depth: **15.75** (ft.) Flow Characteristics: **Fast**

Deposits: ☒ None ☐ Mud ☐ Sludge ☐ Debris ☐ Grease

Infiltration: **None** Pipe Seal Cond: **Unknown**

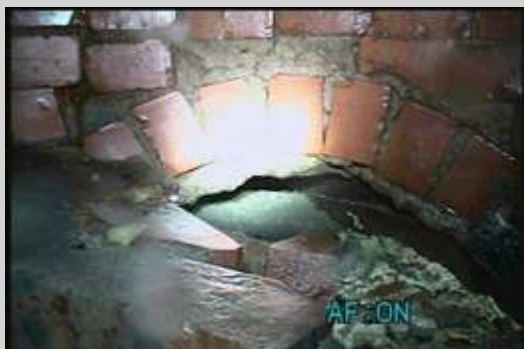
7 O'Clock Inflow

12 in. Circular Gravity Sewer

Pipe In @ 7 O'Clock

Pipe Material: **Clay** ☐ Pipe Lined

Infiltration: **None**
